NASA Contractor Report 3617

Service Evaluation of Aluminum-Brazed Titanium (ABTi) Jet Engine Tailpipe Extensions

S. D. Elrod

CONTRACT NAS1-13681
SEPTEMBER 1982

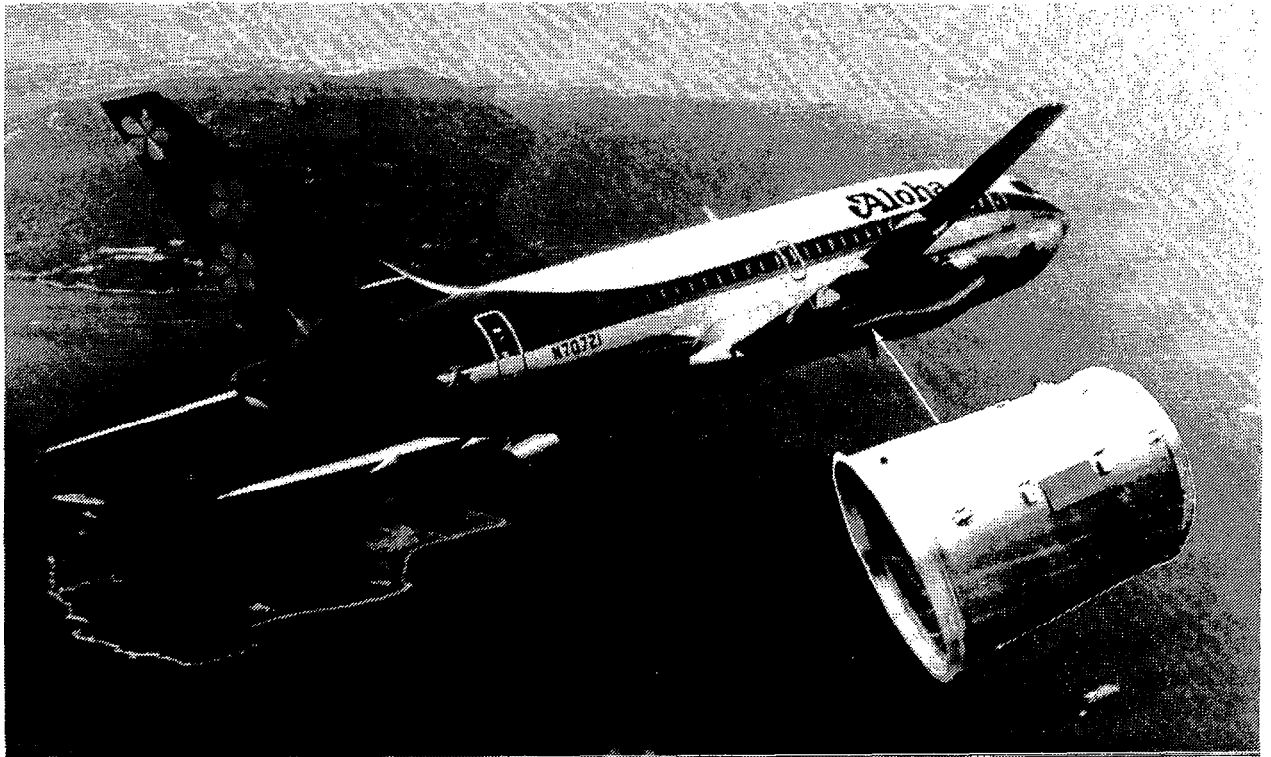
Figure 1. 737 Tailpipe Extension

The ABTi tailpipe extensions are straight cylinders placed between the aft end of the engine and the exhaust nozzle. Figure 1 shows the general configuration of the part and its location on the airplane. The extensions are 91.4 cm (36 in.) long and have a 111.8 cm (44 in.) inside diameter. Both skins are 0.51 mm (0.020 in.) thick Ti-6Al-4V; the inner skin is perforated with a staggered array of 1.3 mm (0.050 in.) diameter holes, giving a 9 percent open area. Figure 2 is a photograph of a section of the inner skin. The core is 0.95 cm (3/8 in.) square cell with 0.076 mm (0.003 in.) thick, perforated and corrugated cell walls made from Ti-3Al-2.5V. The parts were fabricated by Boeing Wichita to the requirements of BAC 5967.

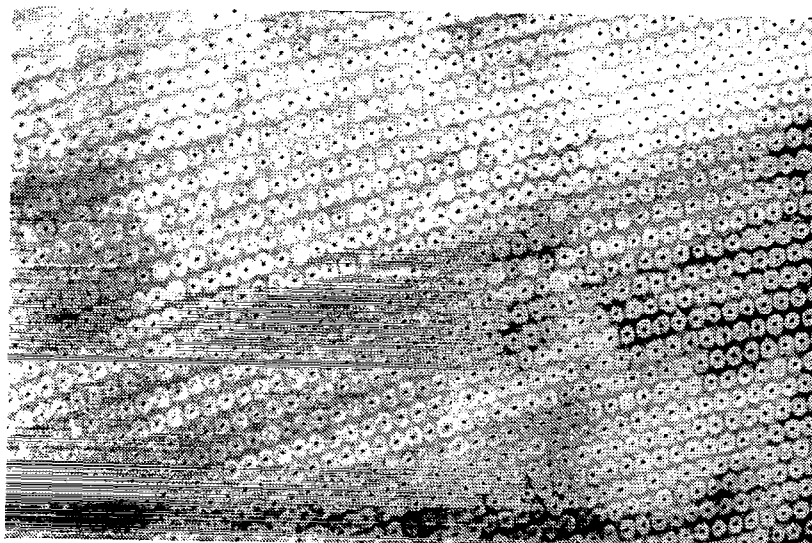
Figure 2. Photograph of Inner Skin Showing Perforations

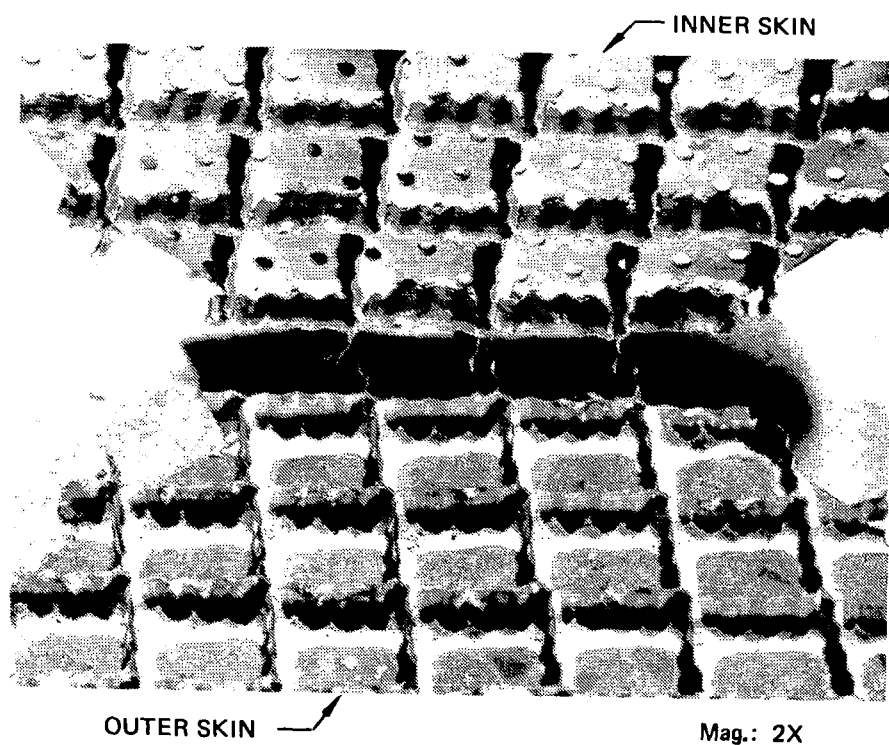
The specimens were cleaned to remove the soot coating and examined. Figure 3 is a photomicrograph of a typical specimen with the inner, perforated skin on top and the outer skin on the bottom. Figure 4a is a scanning electron microscope (SEM) photograph of the core and inner skin at the most severely corroded area; the braze fillet is almost entirely gone. Figure 4b is an SEM photograph of the core and outer skin in the same general area as shown in Figure 4a; there is no evidence of significant corrosion. Figure 5 is an SEM photograph of the core and inner skin at a point approximately 12.7 cm (5 in.) away from the area shown in Figure 4; the braze fillet is severely corroded in the vicinity of the perforations, but is essentially intact a short distance away. A disk cut from approximately halfway up the side of the pipe exhibited significant corrosion, essentially equivalent to that shown in Figure 5. The presence of corrosion on the side of the pipe indicates that the sooty coating is hygroscopic as well as hydrophilic.

*Figure 3. Photomicrograph of the Inside of
7.6 cm (3 in) Specimen Disk*

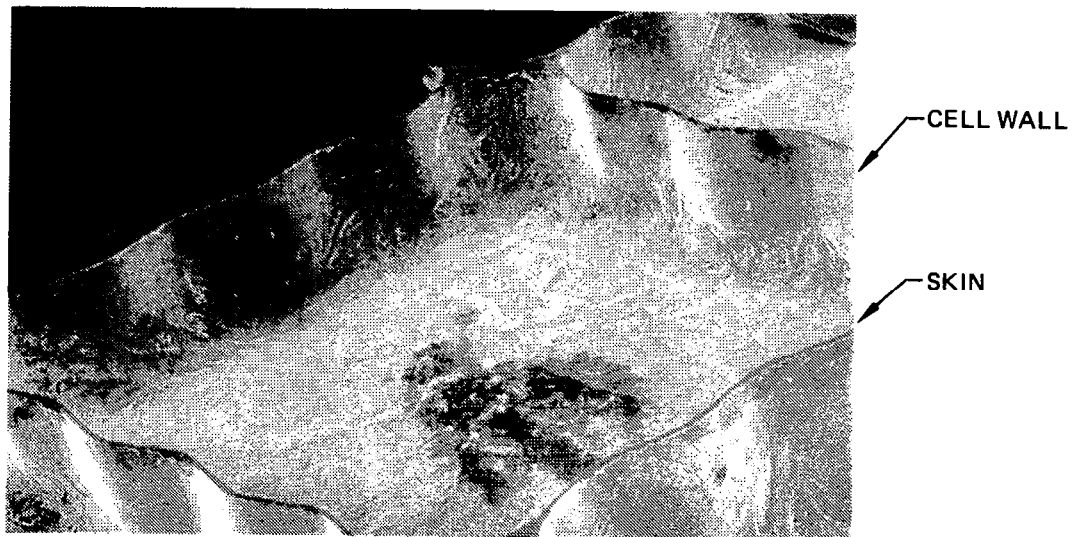
b. Outer Skin Showing No Significant Corrosion

Figure 4. SEM Photographs of the Interior of Cells at the Aft Centerline of Aloha Pipe

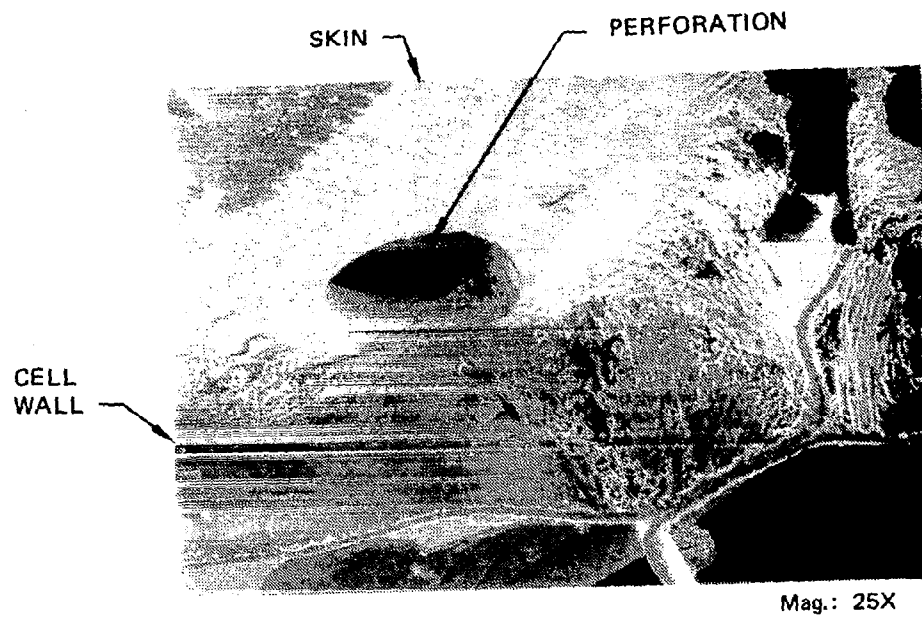
Examination of the disks cut from the Piedmont pipe showed that the anomalies were primarily artifacts from the original braze operation, with only minor, superficial corrosion. A sample cut from the aft end at the bottom centerline exhibited more extensive corrosion (20-40%), essentially equivalent to that shown in Figure 5.

Figure 5. SEM Photograph of the Interior of a Cell Showing Preferential Corrosion in the Vicinity of the Perforation

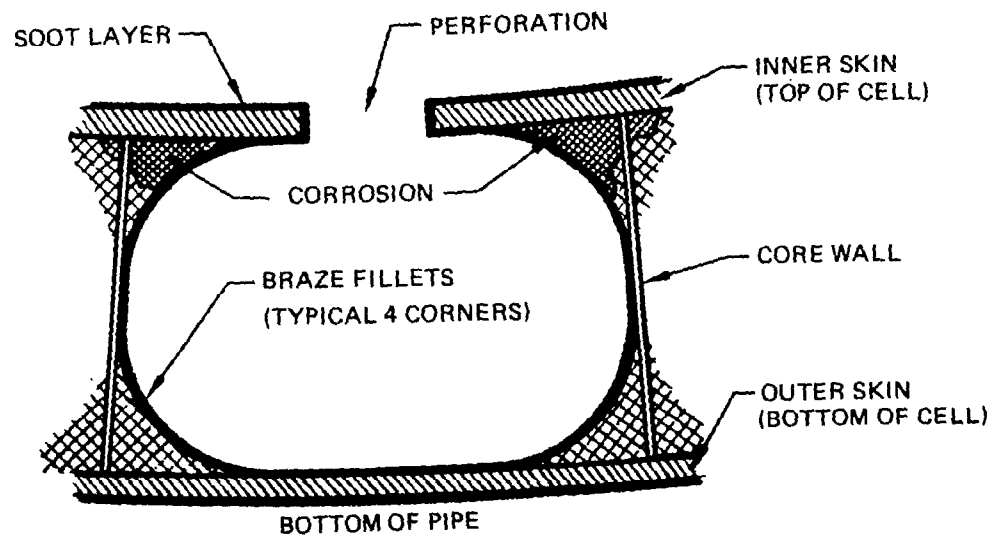
Previous work (refs. 1, 2, and 3) has shown that ABTi ordinarily corrodes only in the presence of liquid water. The absence of corrosion in the bottom of the cell, where water would naturally collect, and the gross corrosion at the top of the cell, where it should be dry, are puzzling. The following could account for the phenomenon (fig. 6):

- The perforations are too small for water to run into the cells. This has been demonstrated by test and by the absence of corrosion in the bottom of the cells.
- The sooty coating is hydrophilic, as demonstrated by test.

- Water coming into contact with the inner skin of the pipe is absorbed by the sooty layer; and to a lesser degree the sooty coating absorbs moisture from the atmosphere. At a skin perforation, the soot wicks a small quantity of water through the perforation and into contact with the adjoining fillets, initiating corrosion. The concept is exemplified in Figure 5, where the fillet is severely corroded in the immediate vicinity of the perforation, but is less corroded a short distance away.
- The quantity of water wicked into the cells is too small to produce any accumulation of water in the bottom of the cells.
- Carbon is cathodic to aluminum and is a known accelerator of corrosion of aluminum in the presence of moisture.

Figure 6. Schematic of a Single Cell Showing Soot Layer and Related Corrosion
